# Manhole Inspection Summary

Manhole # S35A\_\_018MH

Insp Date: **8/6/08 3:42 PM**

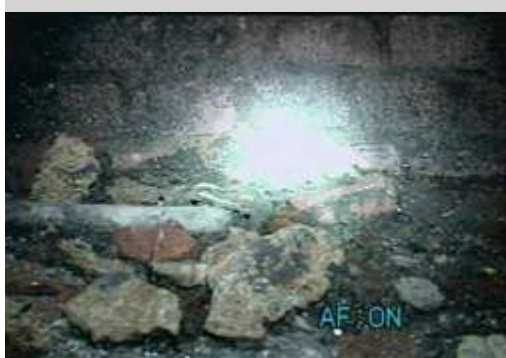
Defect 3

Condition: ☐ Sound ☐ Cracked ☐ Root Intrusion ☐ Deteriorated ☐ Leaks ☒ **Debris**

bench debris

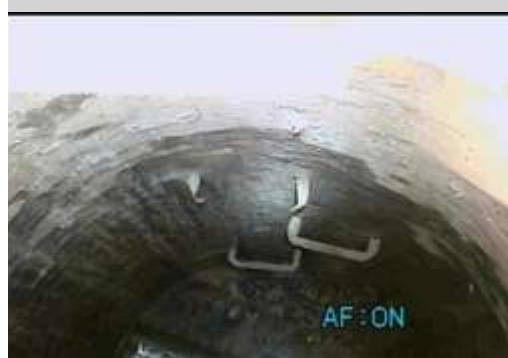
Defect 2

Count: **4** Missing: **2** ☒ **Corroded**

steps

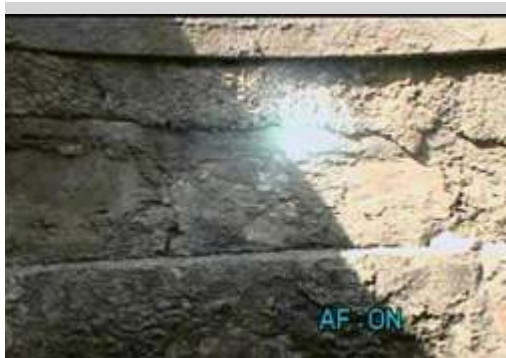
Defect 1

Condition: ☐ Sound ☐ Cracked ☐ Root Intrusion ☐ Loose Brick ☒ **Deteriorated**

Chimney deteriorated  
frame adj

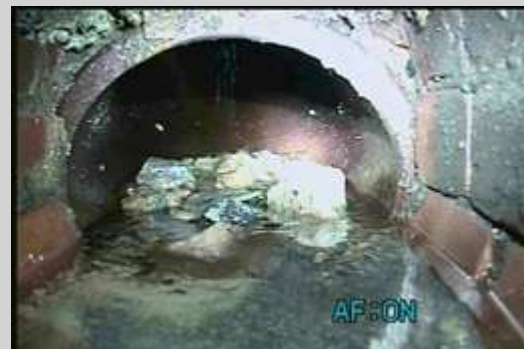
Drop In @ 3 O'Clock

debris
